**US Army Corps
of Engineers®**

Fort Leonard Wood German POW Stonework Context and Survey

June 2006

Final Report

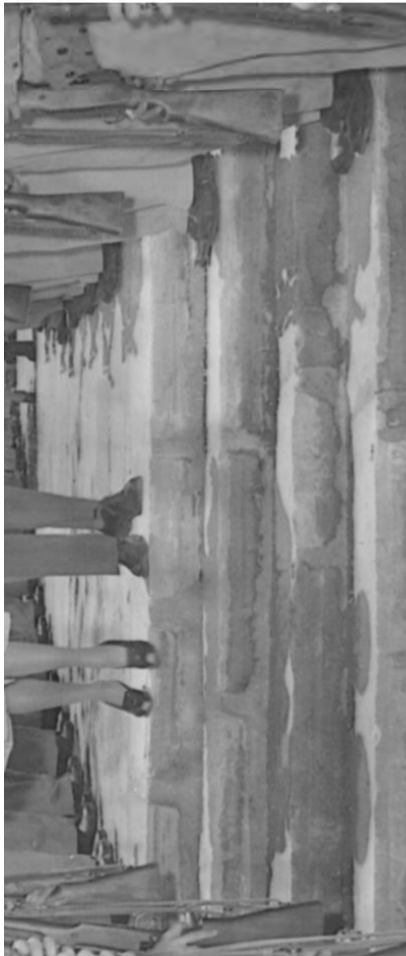
Figure 82. Comparison of mortar joints from 1943 to 2005.

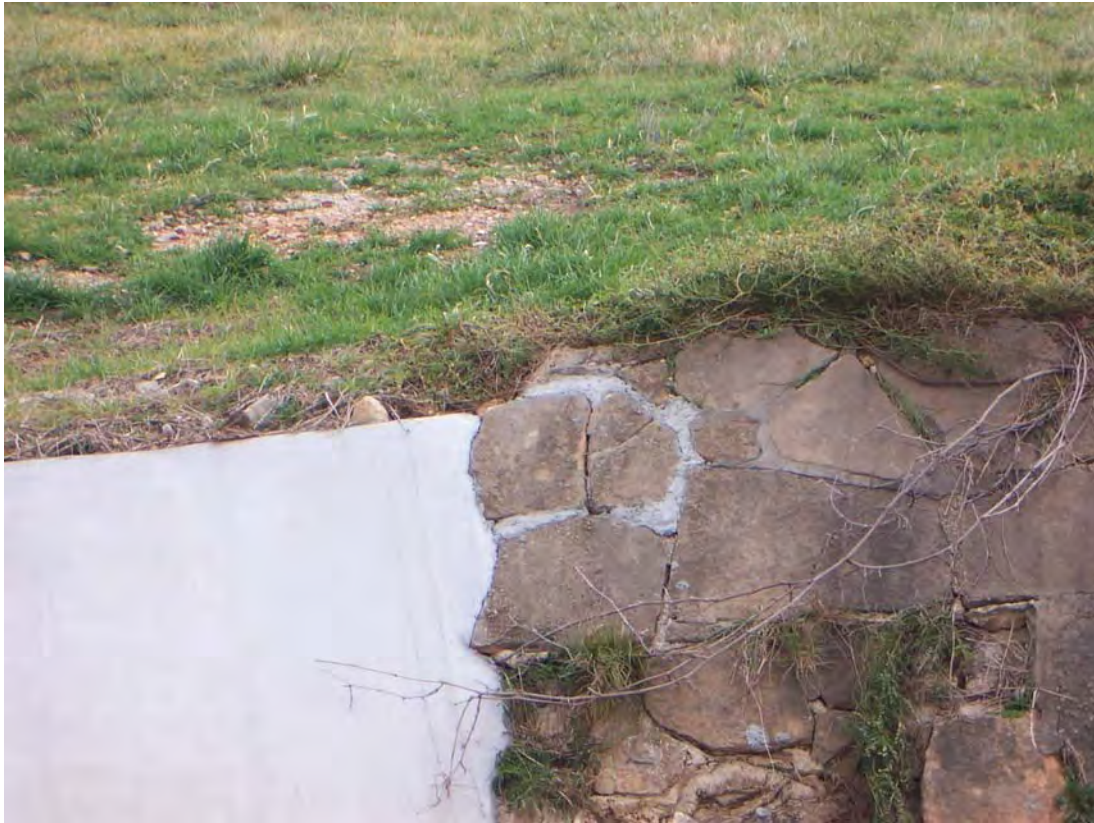
Figure 83. Example of inappropriate mortar replacement and new concrete without tinting at the Nebraska/Minnesota Culvert (ERDC-CERL).

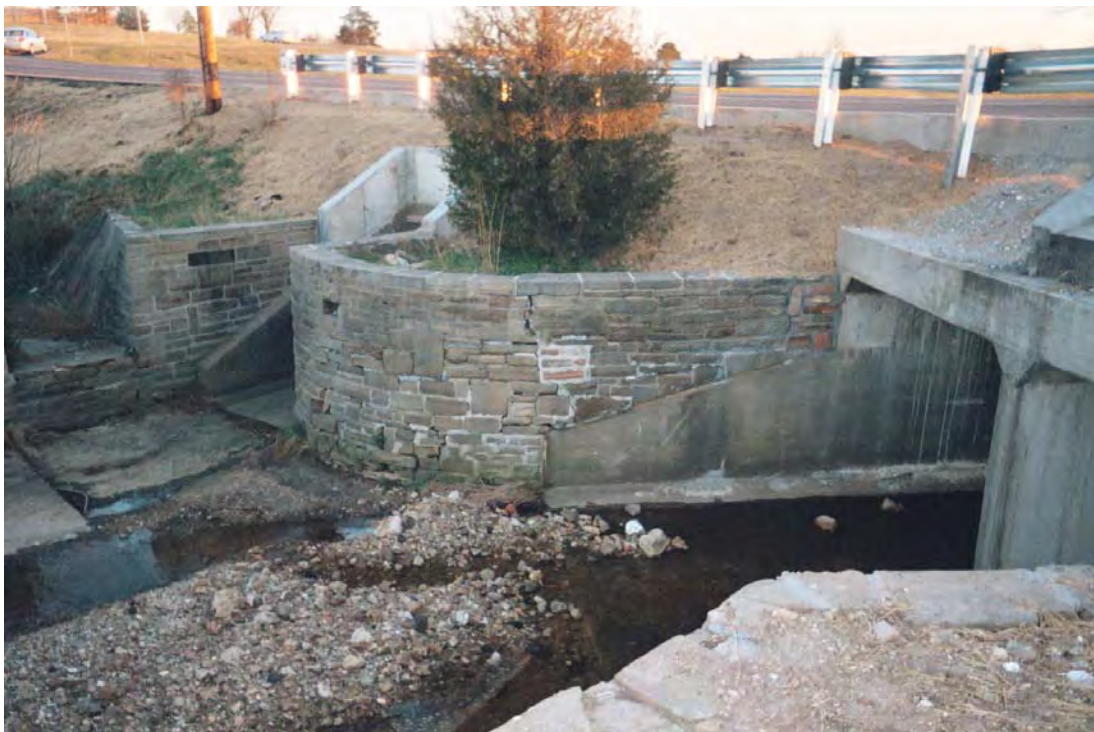
Figure 84. Example of inappropriate mortar replacement and new concrete without tinting at the Nebraska/Minnesota Culvert (ERDC-CERL).

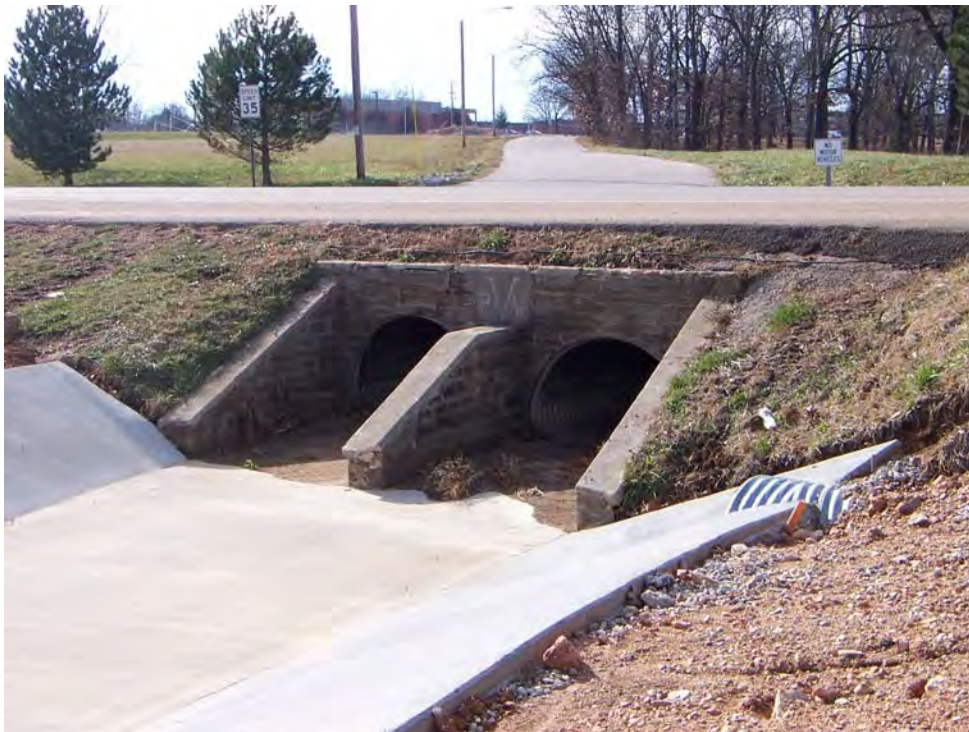
Figure 85. Example of inappropriate new concrete culvert without tinting at the Constitution Avenue Culvert (ERDC-CERL).

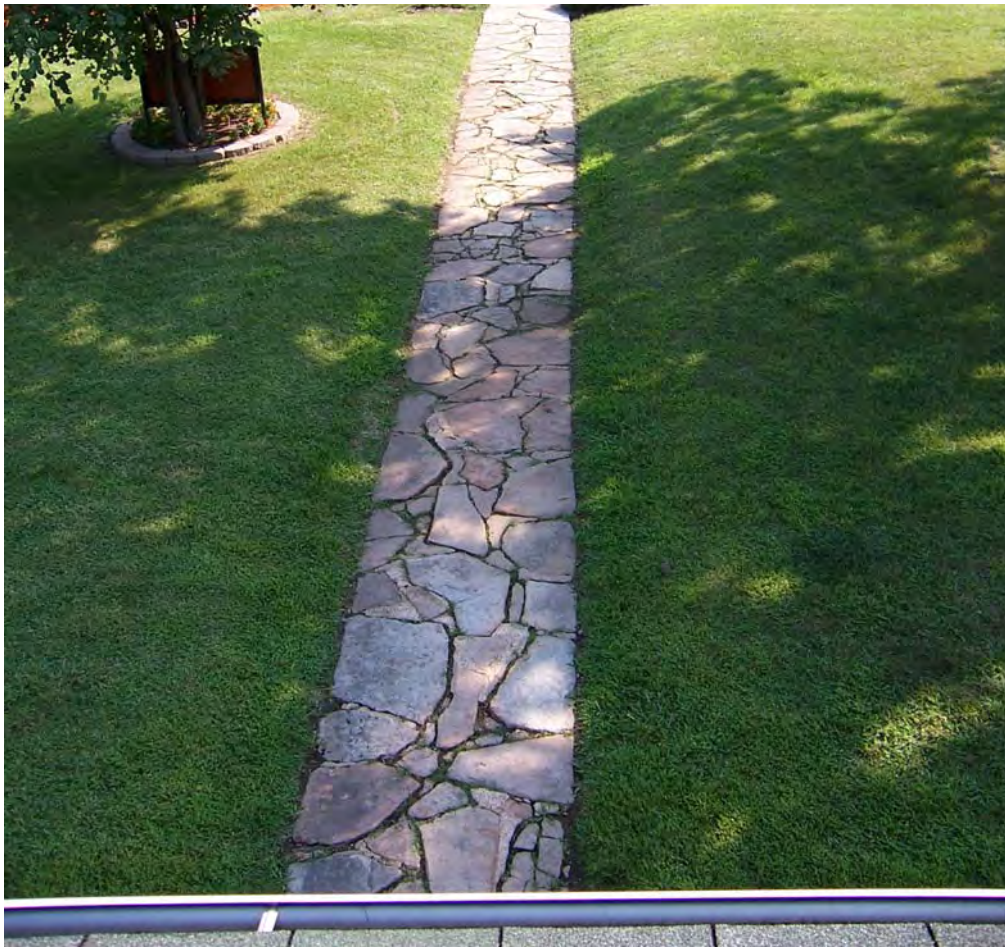
Figure 88. Overhead view of the Garlington House sidewalk, 2004 (ERDC-CERL).

The sidewalk and patio are in serious need of reconstruction. Currently they are extremely uneven due to the freeze/thaw cycle, both of them are missing stones in certain portions, and mortar is missing throughout the area (see Figures 88 and 89). The drawing chapter contains drawings for both the sidewalk and patio. The contractors should utilize these drawings for placement of the stones, although absolute adherence to original placement is not necessary. The sidewalk from the patio to the rear of Garlington has been covered over by soil and grass. FLW should remove these encroachments and if necessary, then rebuild the sidewalk.

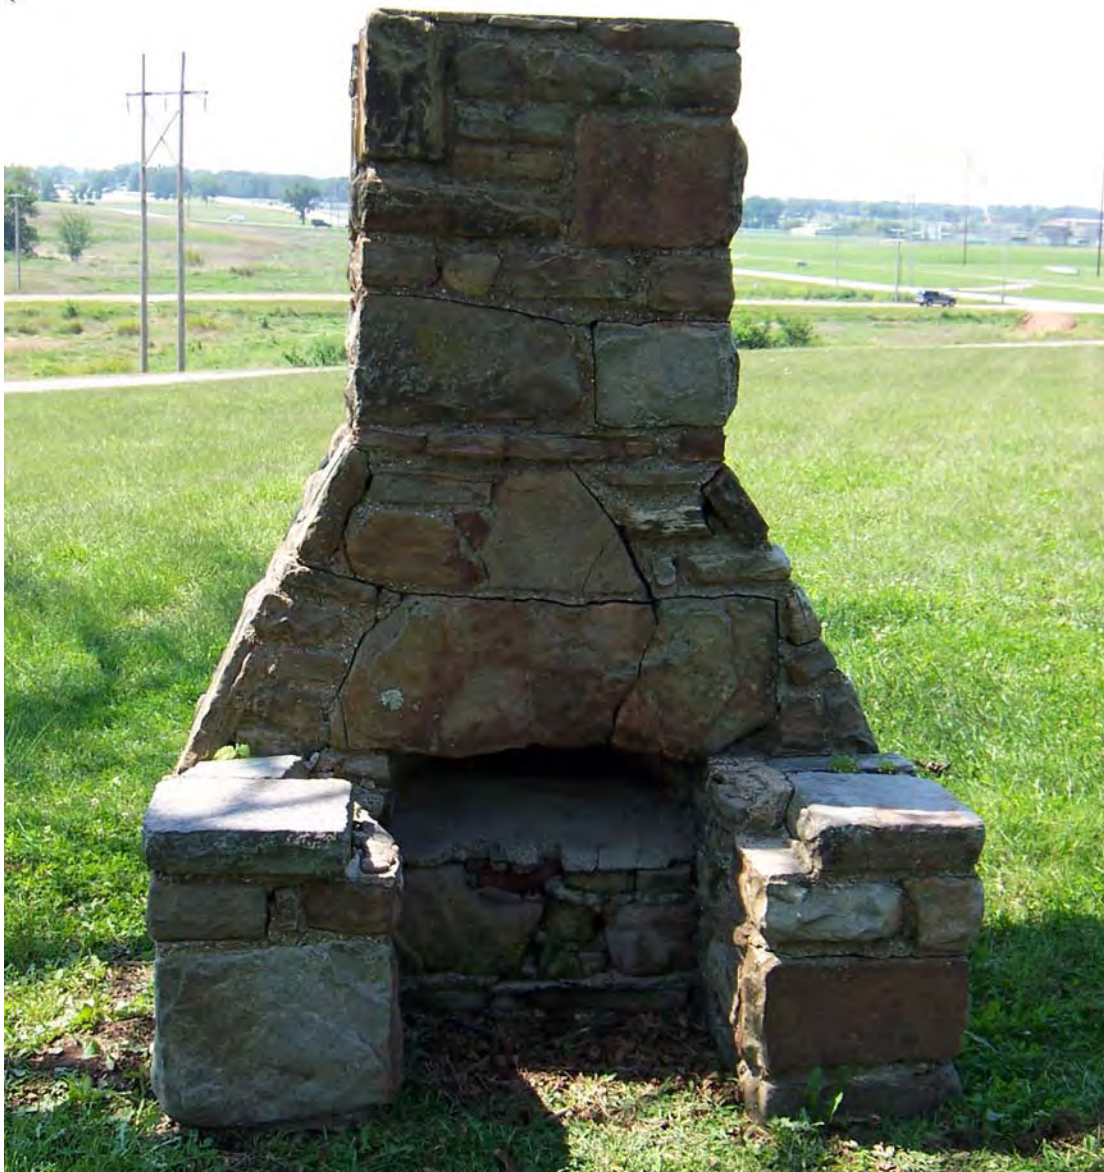
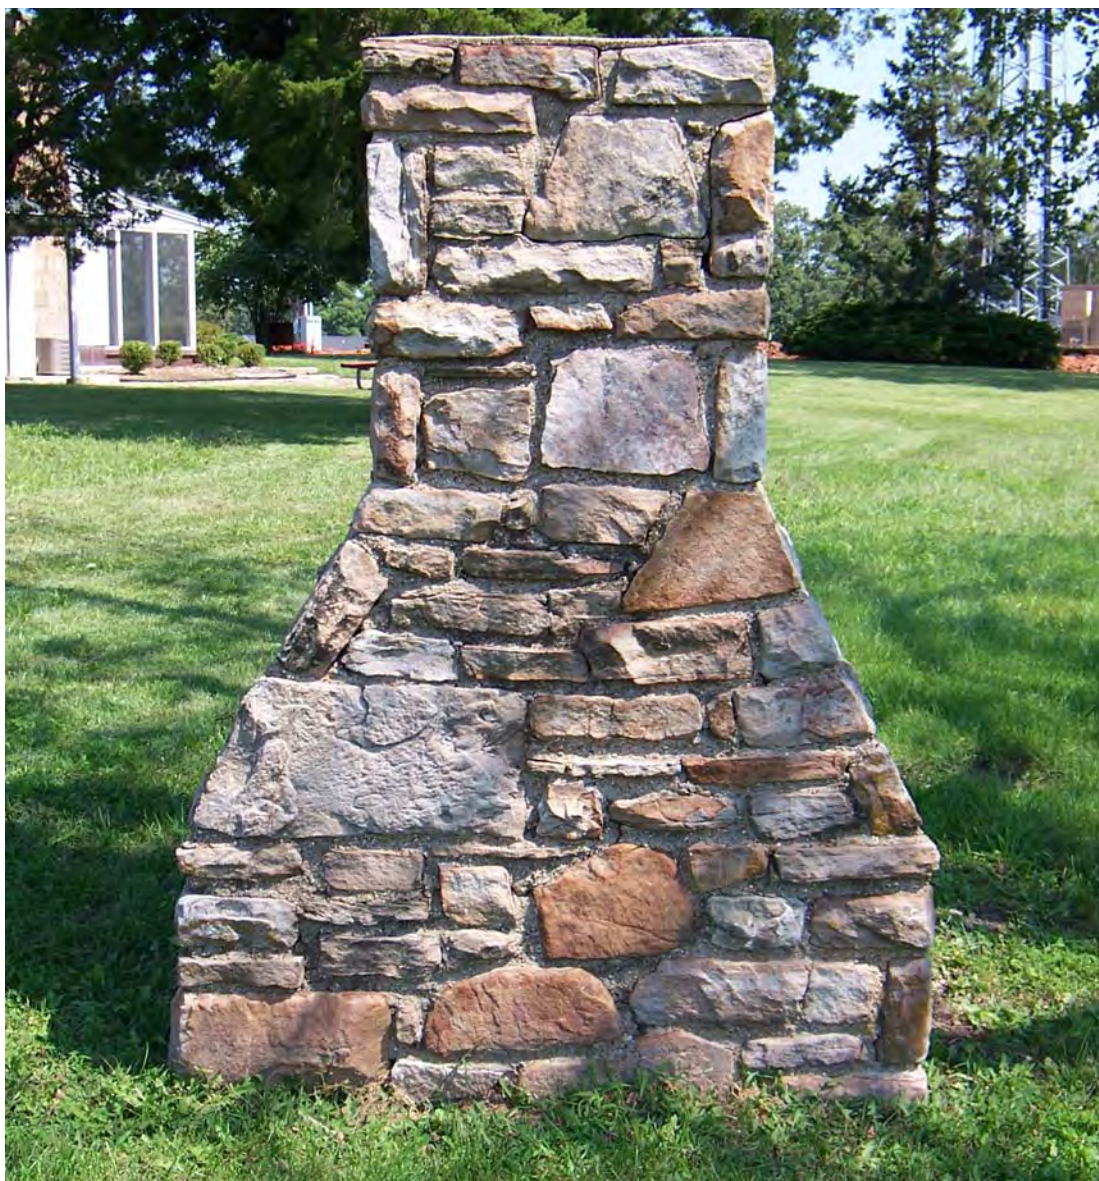
The Garlington House barbeque is located to the southeast of the house and patio (see Figures 90 through 92). The barbeque is in poor condition and needs to be rebuilt. If the barbeque is not rebuilt, it will more than likely be rubble in the next couple of years. It is the opinion of the researchers that the barbeque should be rebuilt next to the patio. The barbeque is currently very remote from the house, thus is not well utilized. If it is reconstructed closer to the house, the visitors to the house will be able to enjoy its craftsmanship. The movement of the barbeque should not hinder its eligibility to the National Register.

Figure 91. Front view of the Garlington House barbeque, 2004 (ERDC-CERL).

Figure 92. Rear view of the Garlington House barbeque, 2004 (ERDC-CERL).

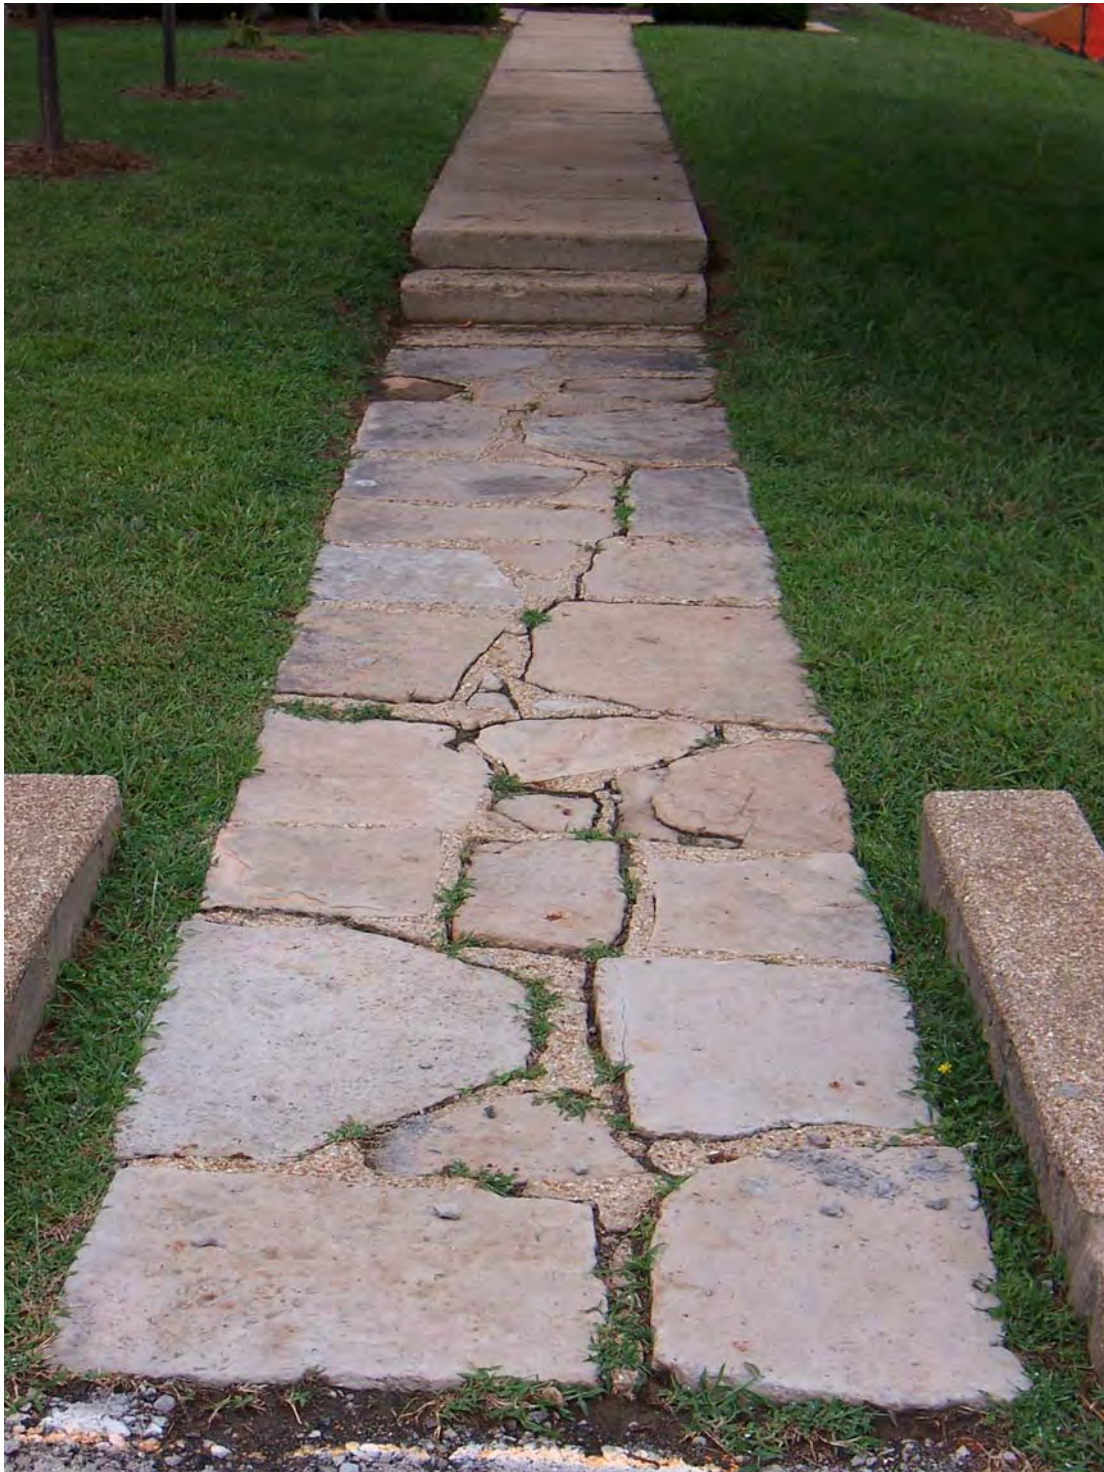
Fort Leonard Wood also replaced the sidewalks that are located around the Old Red Cross Building at some point with concrete (see Figures 98 and 99). Fort Leonard Wood also needs to replace these concrete replacements with stonework culled from elsewhere in the cantonment.

Figure 99. Sidewalk at the Old Red Cross Building, 2004 (ERDC-CERL).
