**US Army Corps
of Engineers®**

Fort Leonard Wood German POW Stonework Context and Survey

June 2006

Final Report

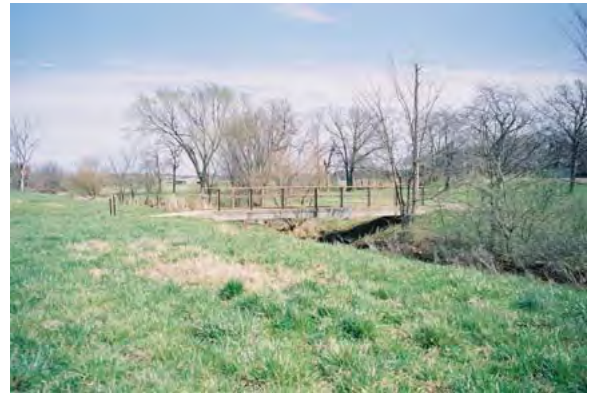
14. Near Constitution Avenue and Kansas Avenue
Noncontributing steel and concrete bridge

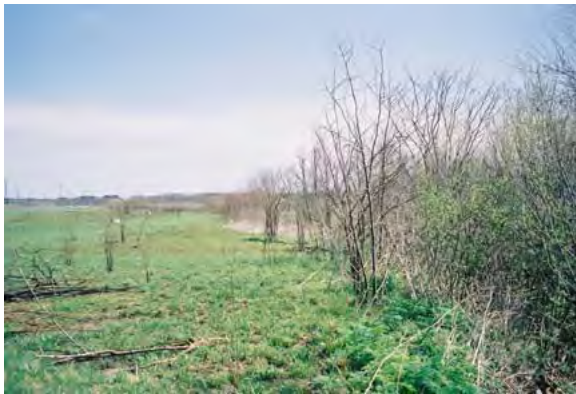
15. West of softball field complex on Minnesota Avenue
Open creek

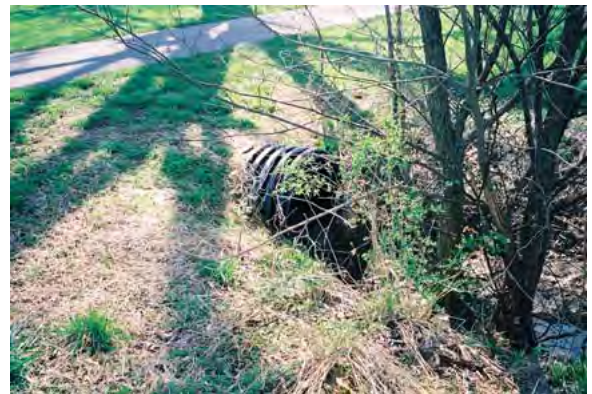
16. West of softball field complex on Minnesota Avenue
Noncontributing plastic culvert

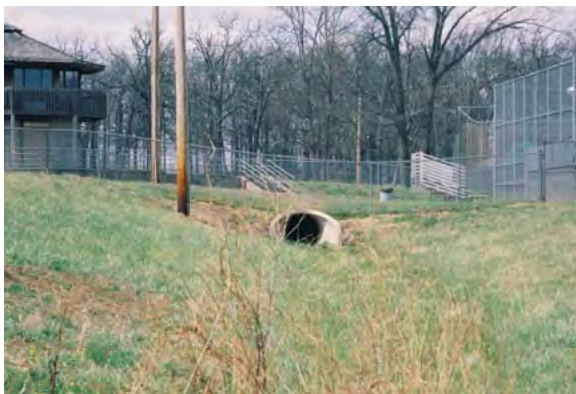
17. In the softball field complex on Minnesota Avenue
Noncontributing concrete culvert

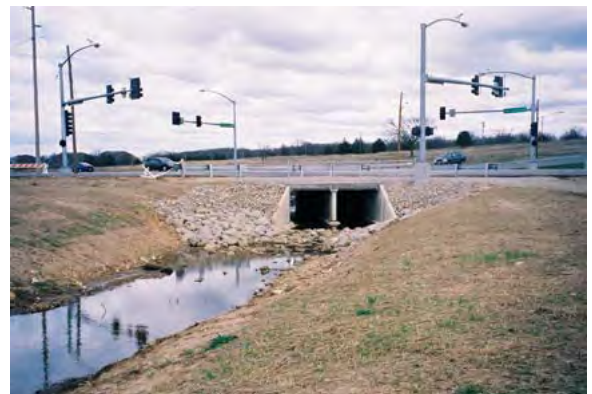
18. Southwest of the intersection of Nebraska Avenue and Minnesota Avenue
Noncontributing concrete culverts

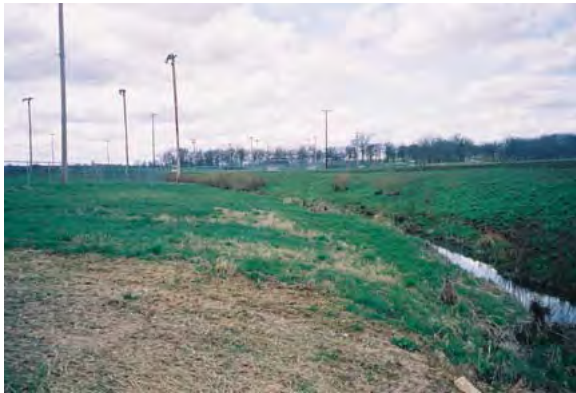
19. Near Nebraska Avenue and Minnesota Avenue
Open creek bed with no stonework

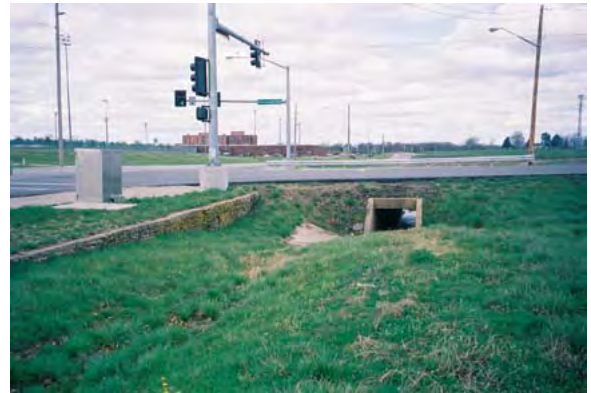
20. Southeast of the intersection of Nebraska Avenue and
Minnesota Avenue
Noncontributing concrete culvert

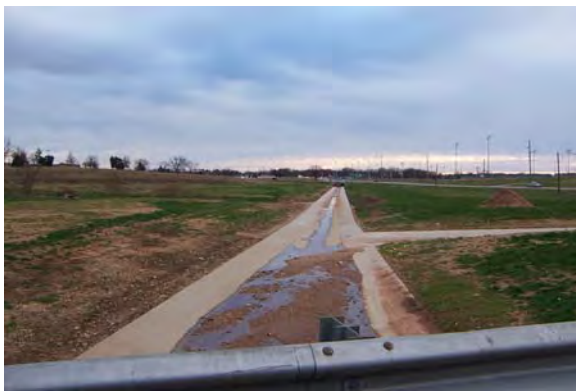
21. Ditch between the Nebraska-Minnesota culvert and
Replacement Avenue
Noncontributing poured concrete ditch

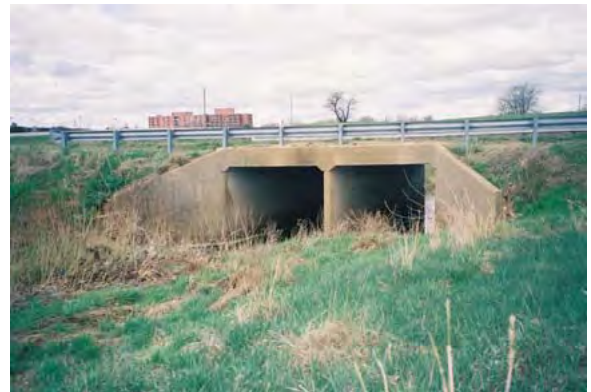
22. Southeast of the intersection of Nebraska Avenue and
Replacement Avenue
Noncontributing concrete culverts

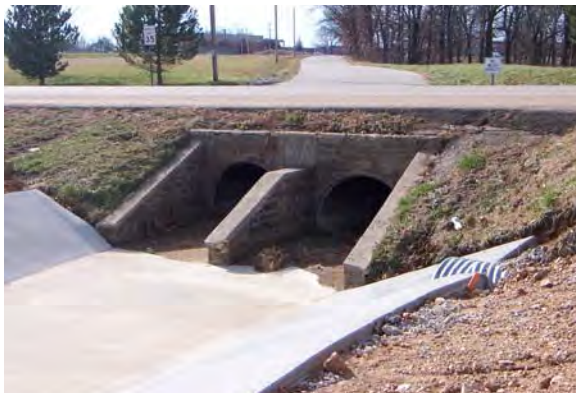
23. Southeast of the intersection of Constitution Avenue and
Replacement Avenue
Noncontributing poured concrete ditch

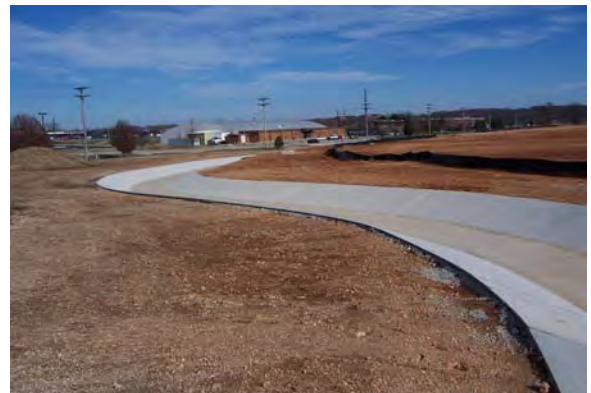
24. Replacement Avenue
Noncontributing poured concrete ditch

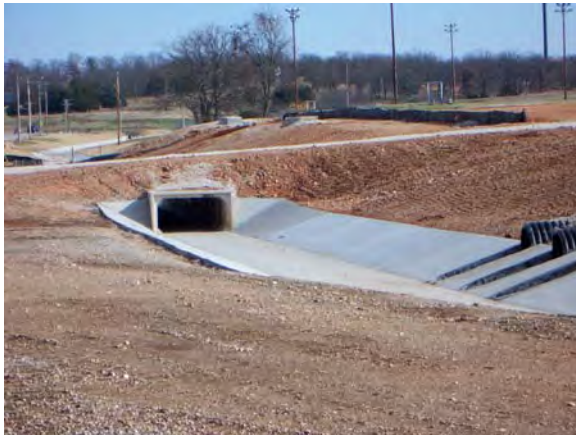
25. Replacement Avenue
Noncontributing concrete culvert/bridge and poured concrete ditch

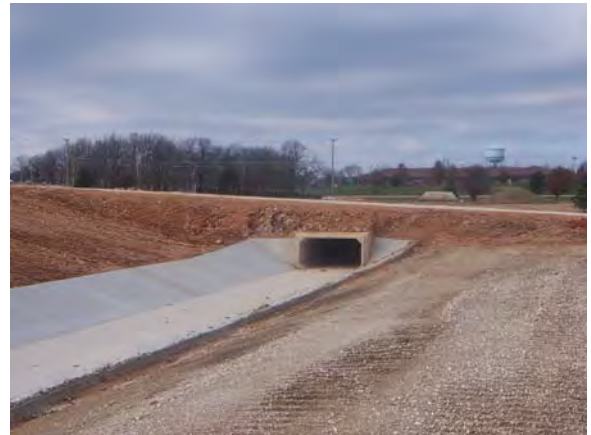
26. Replacement Avenue
Noncontributing concrete culvert/bridge and poured concrete culvert

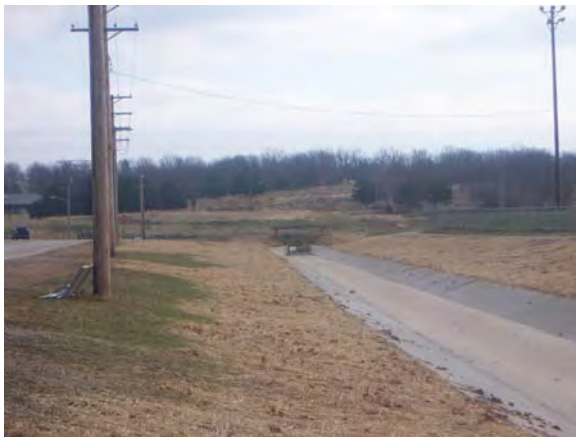
27. Looking east down Replacement Avenue at new culvert
Noncontributing poured concrete ditch

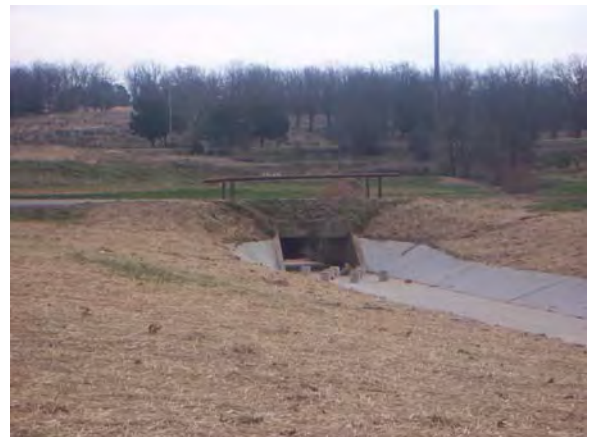
28. South of the intersection of Nebraska and Replacement Avenues
Noncontributing poured concrete ditch, culvert, and bridge

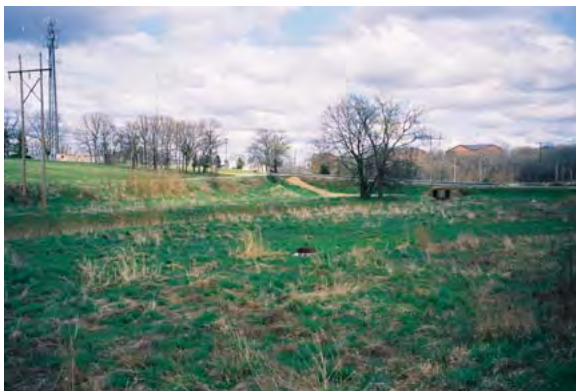
29. South of Garlington House and west of Michigan Avenue
Noncontributing concrete culvert/bridge (background) with open creek area (foreground)

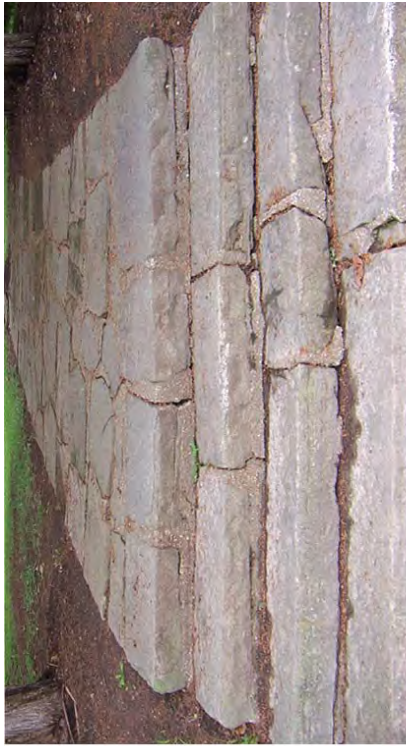
2005

Note similarities between mortar joints in 1943 vs 2005.

Figure 82. Comparison of mortar joints from 1943 to 2005.

When relaying stone with the original mixture of mortar be sure to go up to stone and not have mortar over stone.

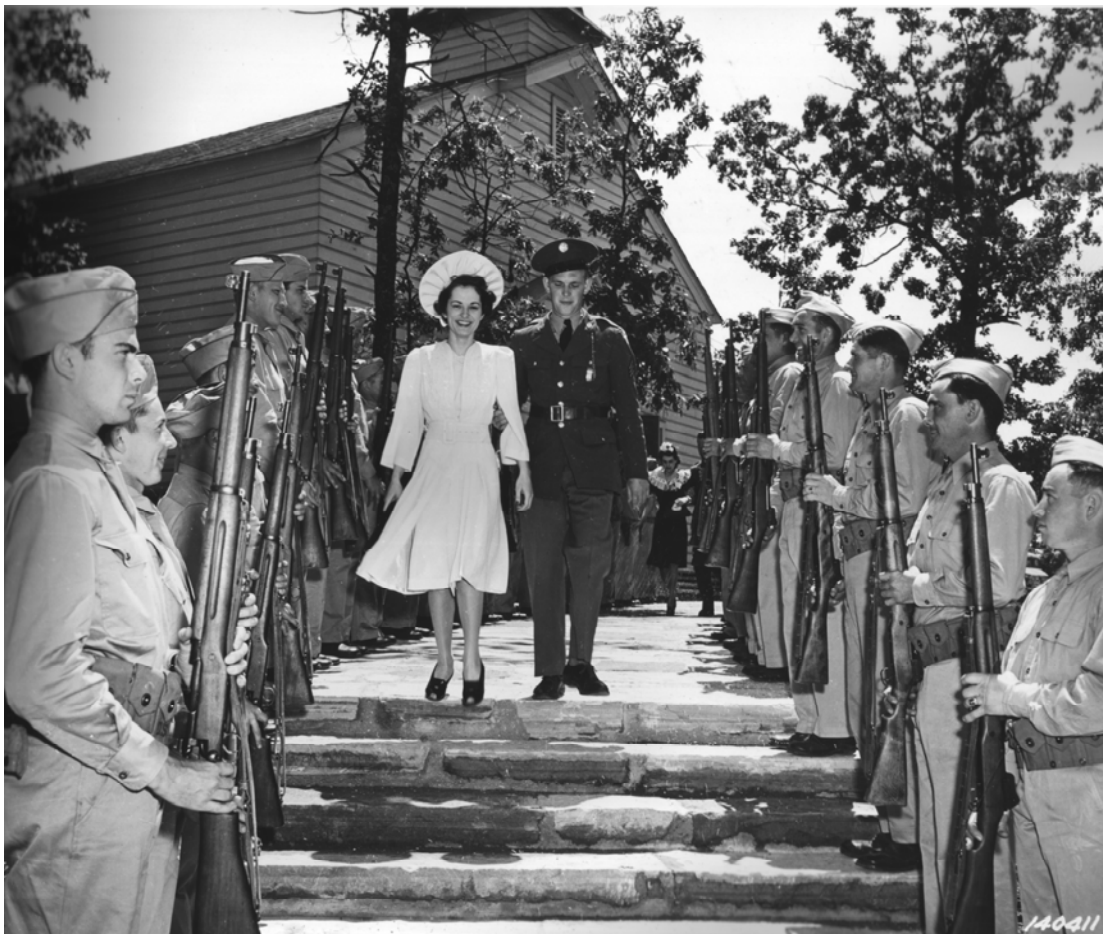
The stonework in the WWII Temporary Building Historic District is in poor to fair condition. Most of the stonework in this historic district primarily requires maintenance and vegetation clearing.

The other issue is that FLW has ignored the stonework in the planning and construction of the three memorial groves. The stonework that once led to the entrance of a chapel (see Figure 86) now just ends in grass and trees (see Figure 87). FLW needs to integrate the steps and circular sidewalk that leads from the corner of Caisson Drive and Pine Street into the sidewalks of the memorial groves.

Figure 86. Stonework in the WWII Temporary Historic District not longer after it was constructed (NARA College Park, RG 111-SC, photo 140411).

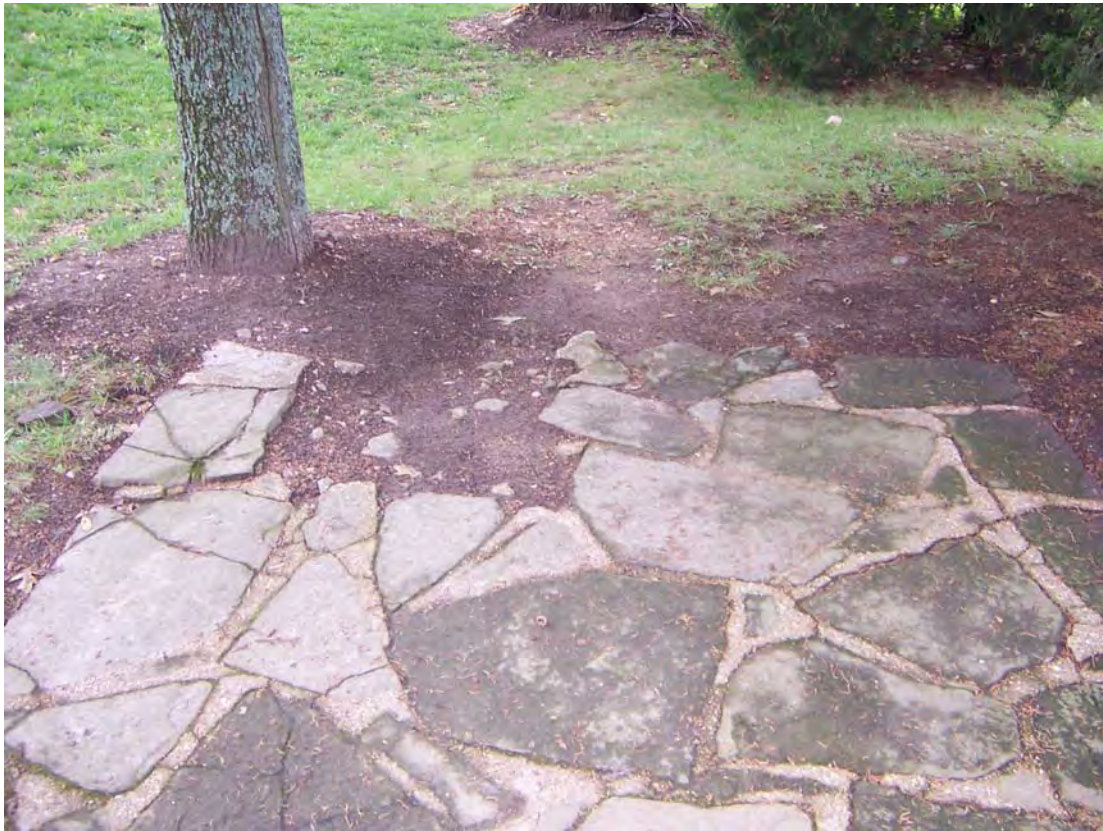
Figure 87. Abrupt end to stonework sidewalk in the WWII Temporary Building Historic District [former location of a chapel], 2004 (ERDC-CERL).

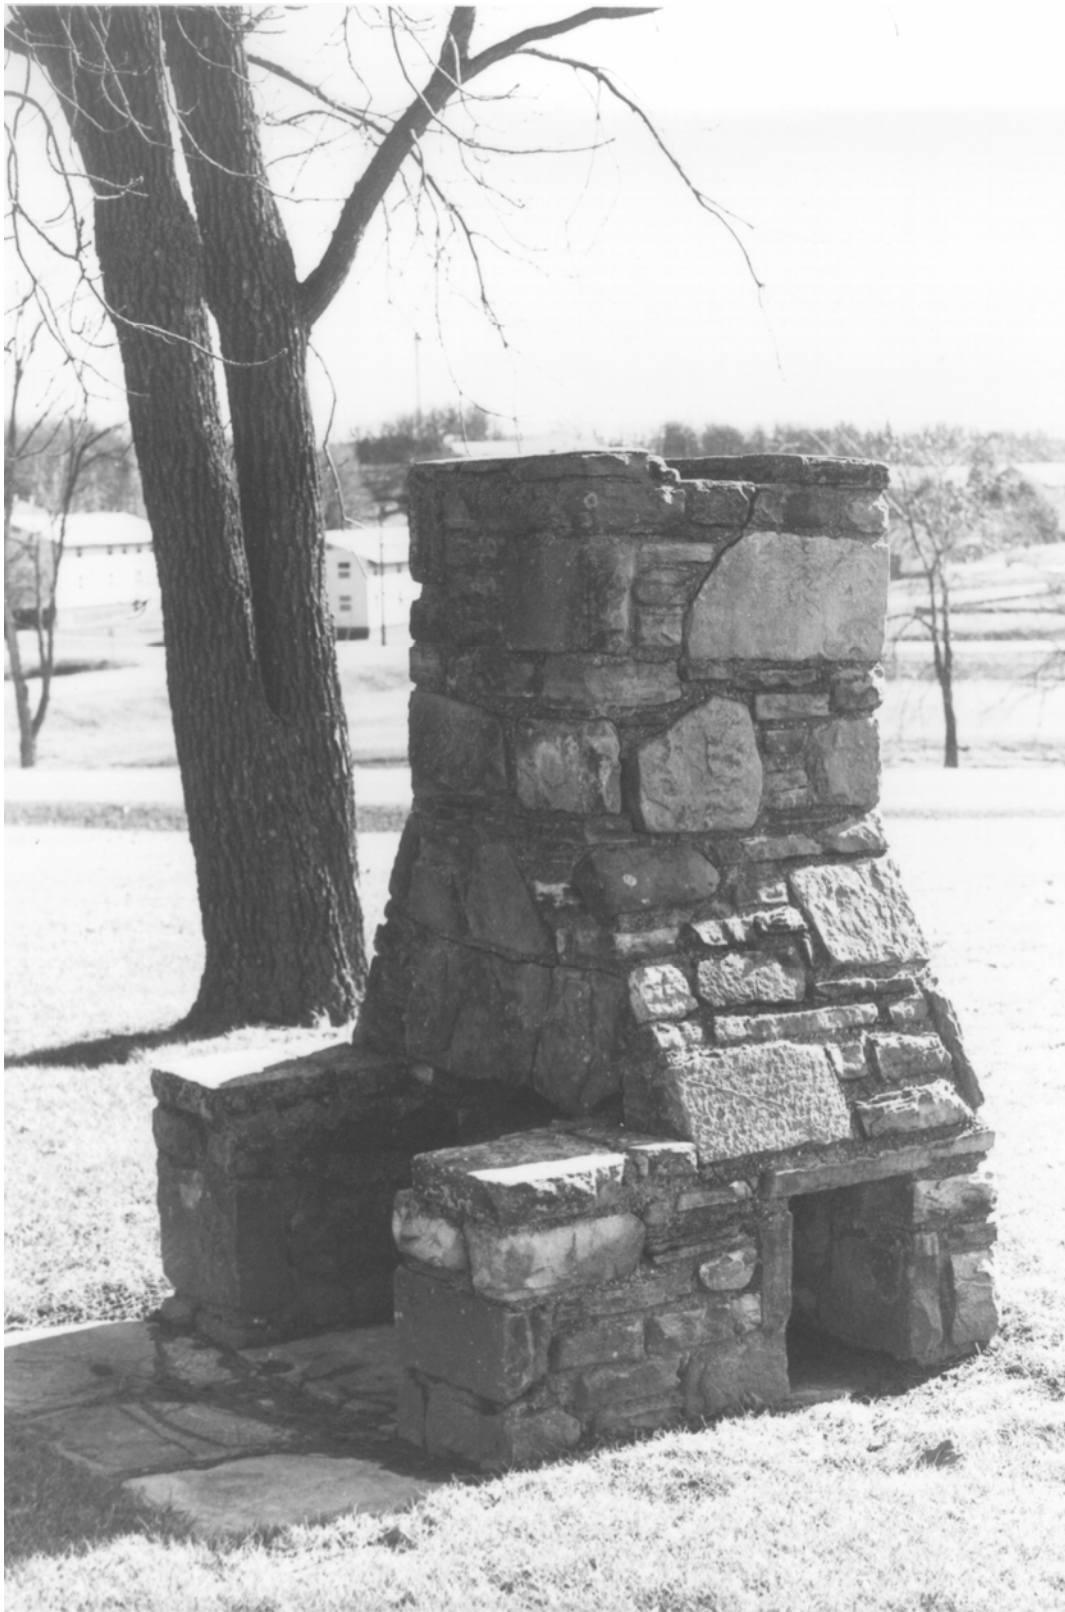
The Garlington House barbeque is located to the southeast of the house and patio (see Figures 90 through 92). The barbeque is in poor condition and needs to be rebuilt. If the barbeque is not rebuilt, it will more than likely be rubble in the next couple of years. It is the opinion of the researchers that the barbeque should be rebuilt next to the patio. The barbeque is currently very remote from the house, thus is not well utilized. If it is reconstructed closer to the house, the visitors to the house will be able to enjoy its craftsmanship. The movement of the barbeque should not hinder its eligibility to the National Register.

Figure 90. Oblique view of the Garlington House barbeque, 1987 (courtesy Harland Bartholomew).

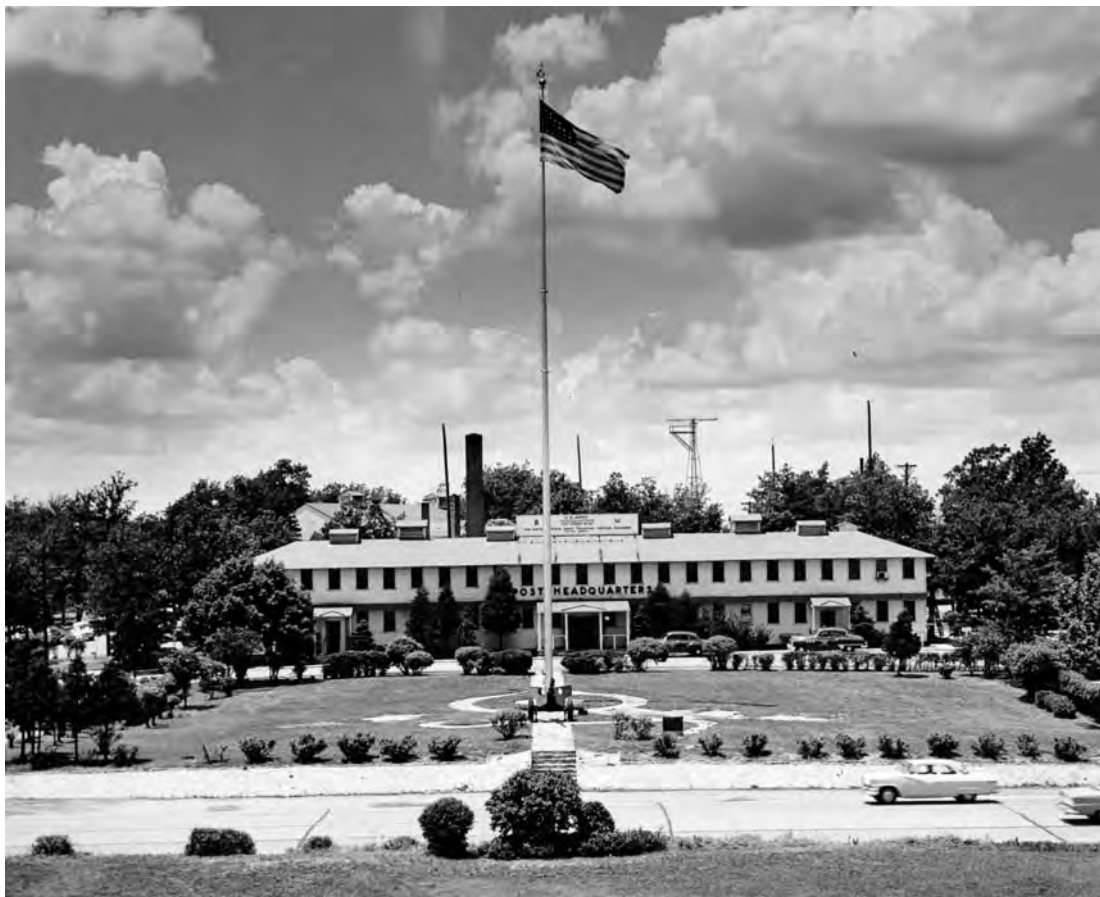
Currently the sidewalks are mostly in a poor condition. Fort Leonard Wood replaced the POW stonework sidewalk from the front of the Old Post Headquarters to the steps that go down to Missouri Avenue in 1984 (at this point they also replaced the original inscription located at the top of the steps). Fort Leonard Wood needs to remove the replacement concrete with stonework culled from non-eligible pieces of stonework elsewhere in the cantonment (see Figures 93 through 97).

Figure 93. Historic view of the Old Post Headquarters with POW stonework sidewalk, no date (courtesy FLW History Office).

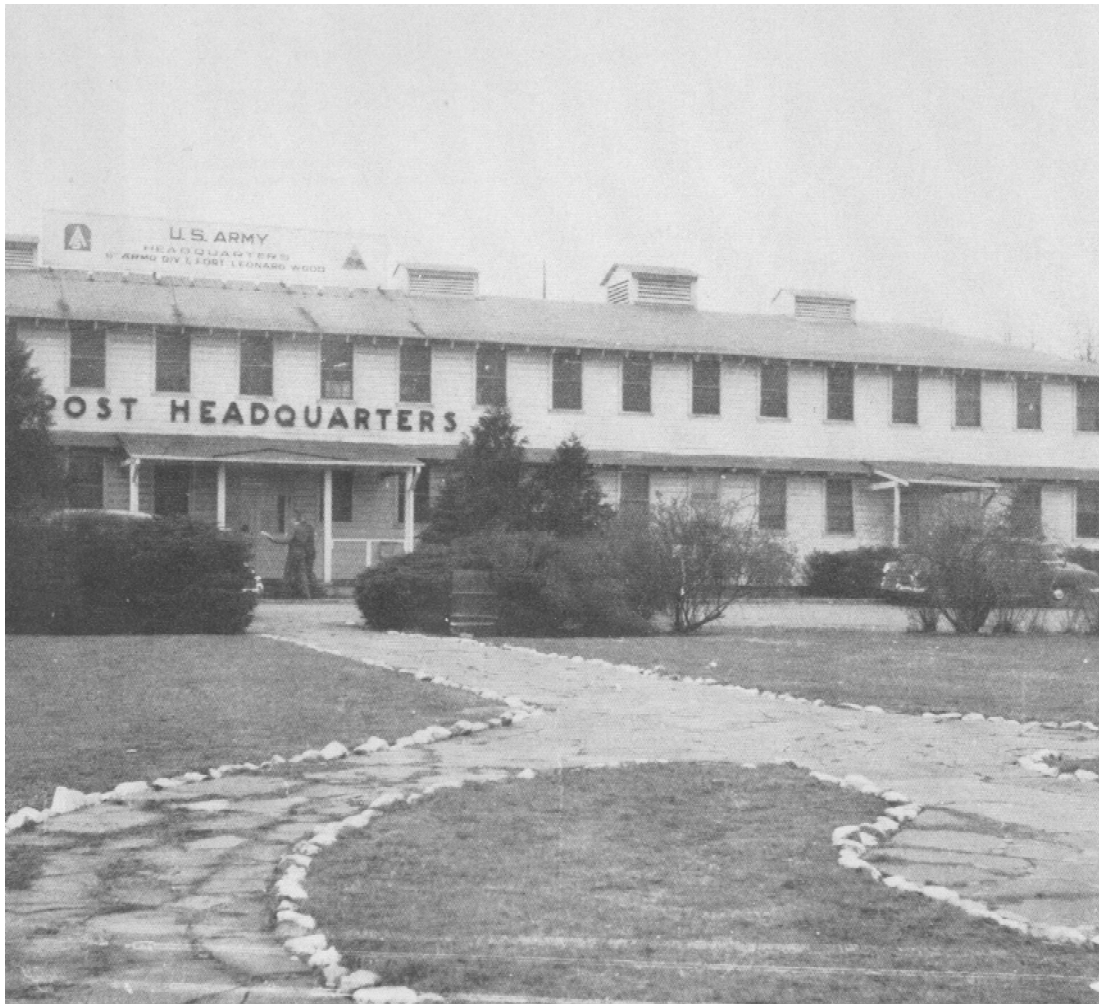
Figure 94. Historic view of the Old Post Headquarters with POW stonework sidewalk, no date (courtesy FLW History Office).

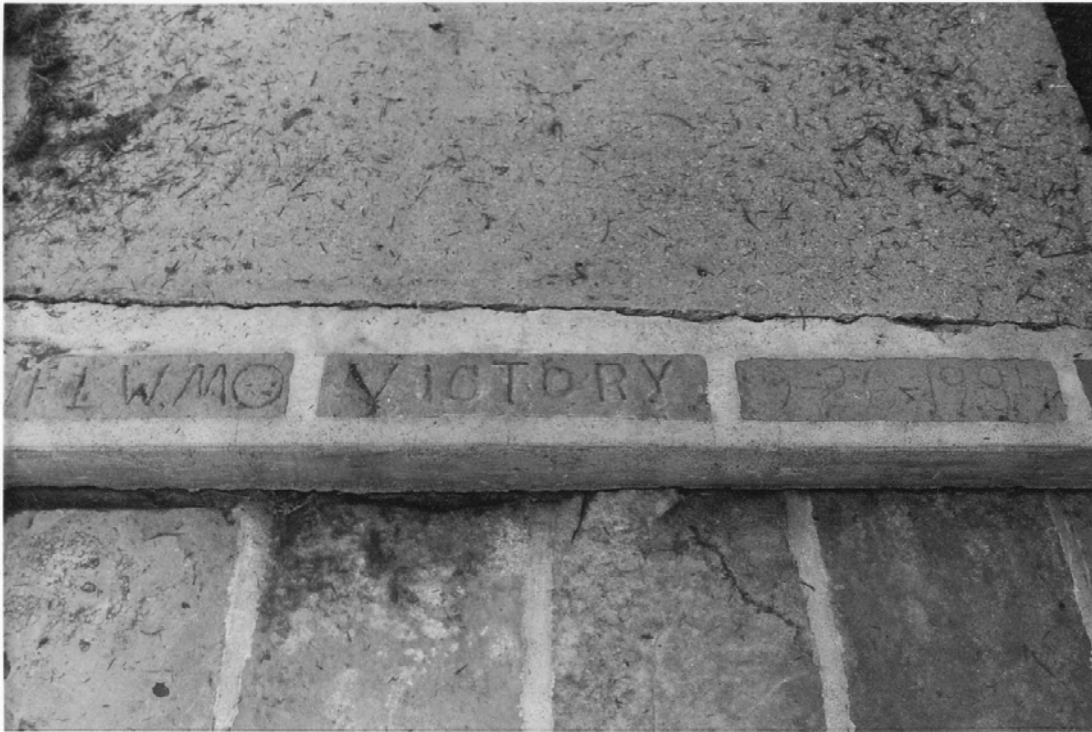
Figure 95. Inscription at top of steps at the Old Post Headquarters, 1987 (courtesy Harland Bartholomew).

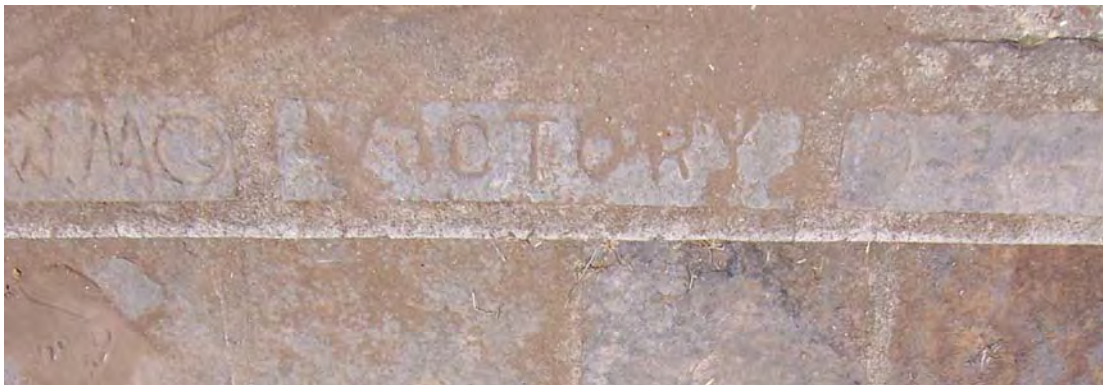
Figure 96. Steps at the Old Post Headquarters, 2004 (ERDC-CERL).

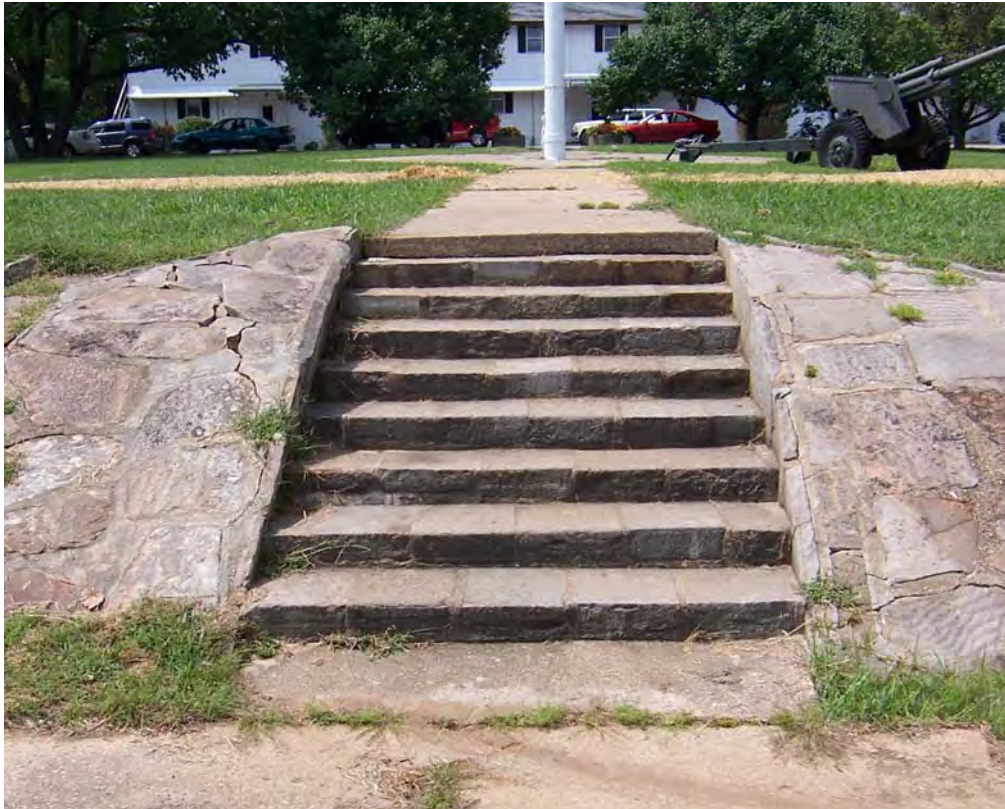
Figure 97. Steps at the Old Post Headquarters, 2004 (ERDC-CERL).

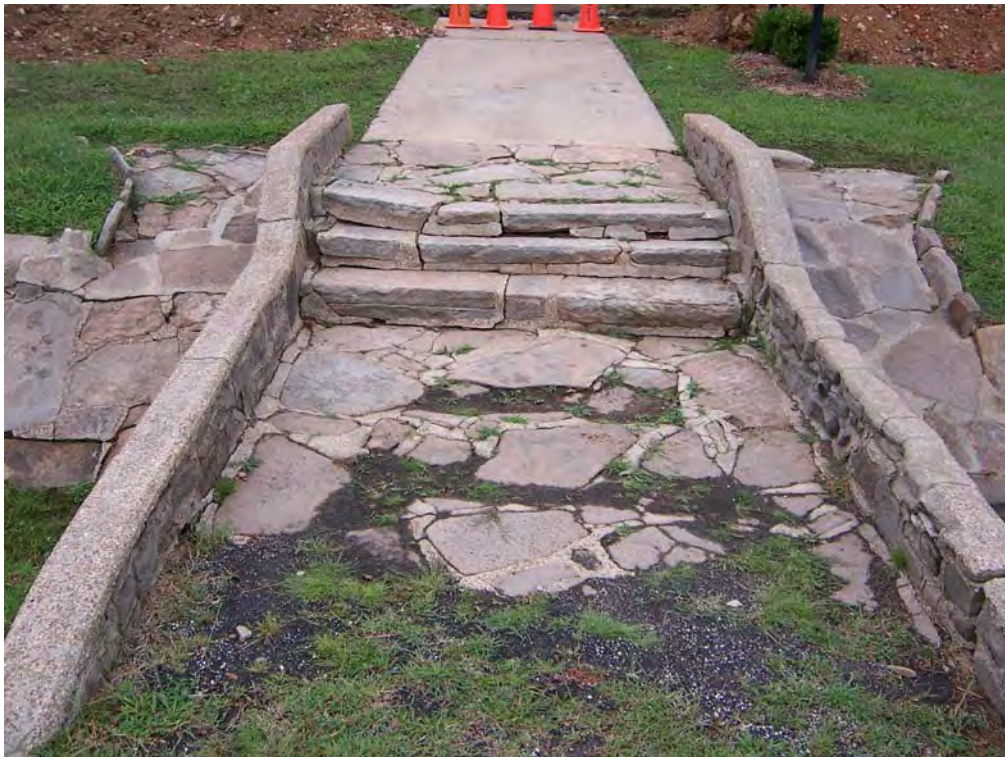
Fort Leonard Wood also replaced the sidewalks that are located around the Old Red Cross Building at some point with concrete (see Figures 98 and 99). Fort Leonard Wood also needs to replace these concrete replacements with stonework culled from elsewhere in the cantonment.

Figure 98. Steps at the Old Red Cross Building, 2004 (ERDC-CERL).
